Re: Project Notification Form – Phase II Demolitions – Uniroyal Complex, 154 Grove Street  
and Facemate Complex, 5 West Main Street, Chicopee, MA

**PROJECT NOTIFICATION FORM**

Project Name Uniroyal/Facemate Complex – Phase II Demolitions  
Location / Address 154 Grove Street (Uniroyal) and 5 West Main Street (Facemate)  
City / Town Chicopee Falls, MA 01020  
Project Proponent  
Name Thomas Haberlin, Economic Development Director, Office of Community Development  
Address 17 Springfield Street  
City / Town Chicopee, MA 01013  
Telephone # (413) 519-7167

Uniroyal/ Facemate Complex  
Phase II Demolitions  
Chicopee, MA

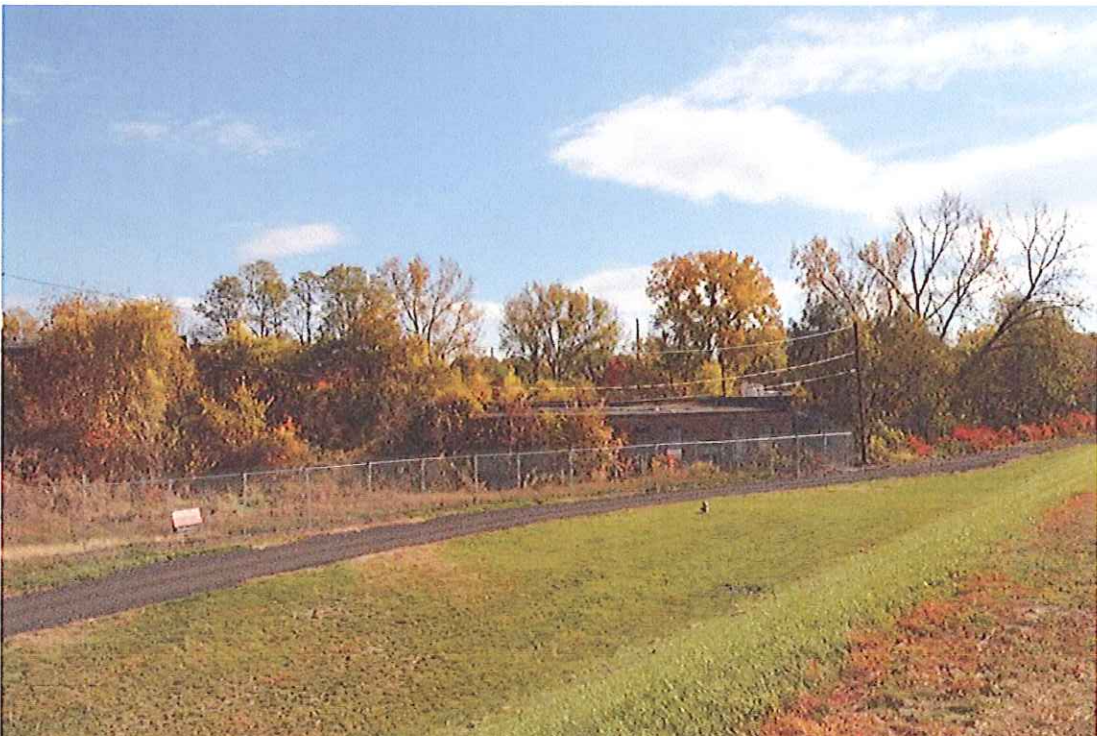
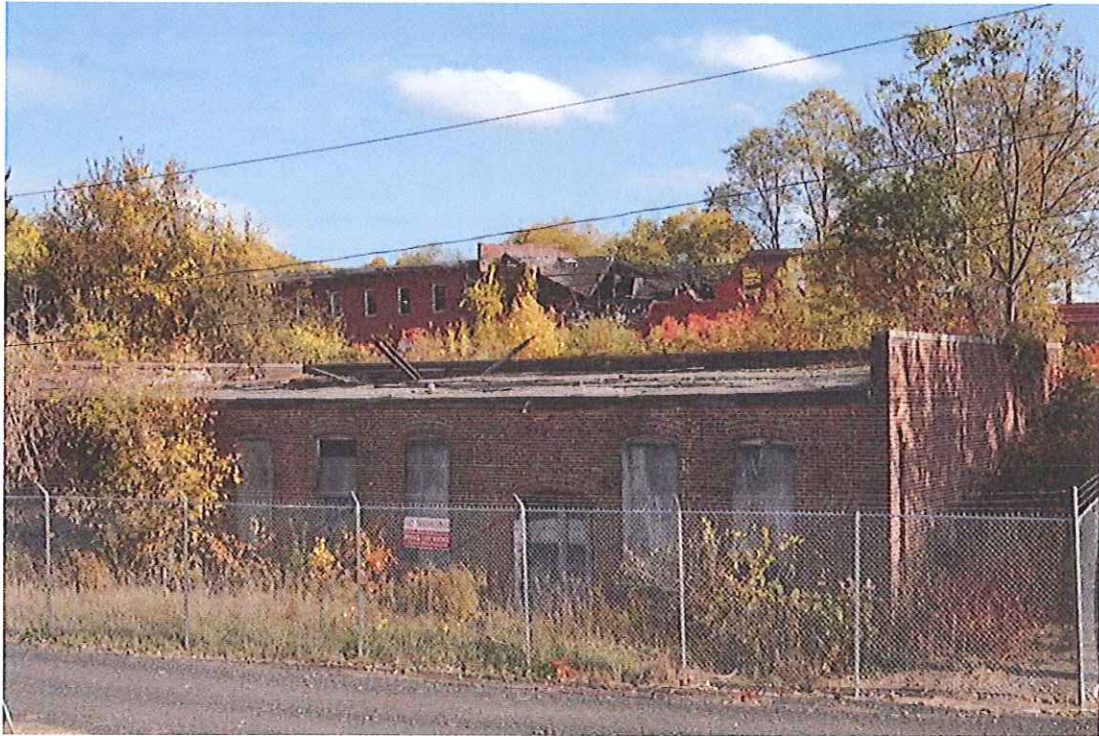
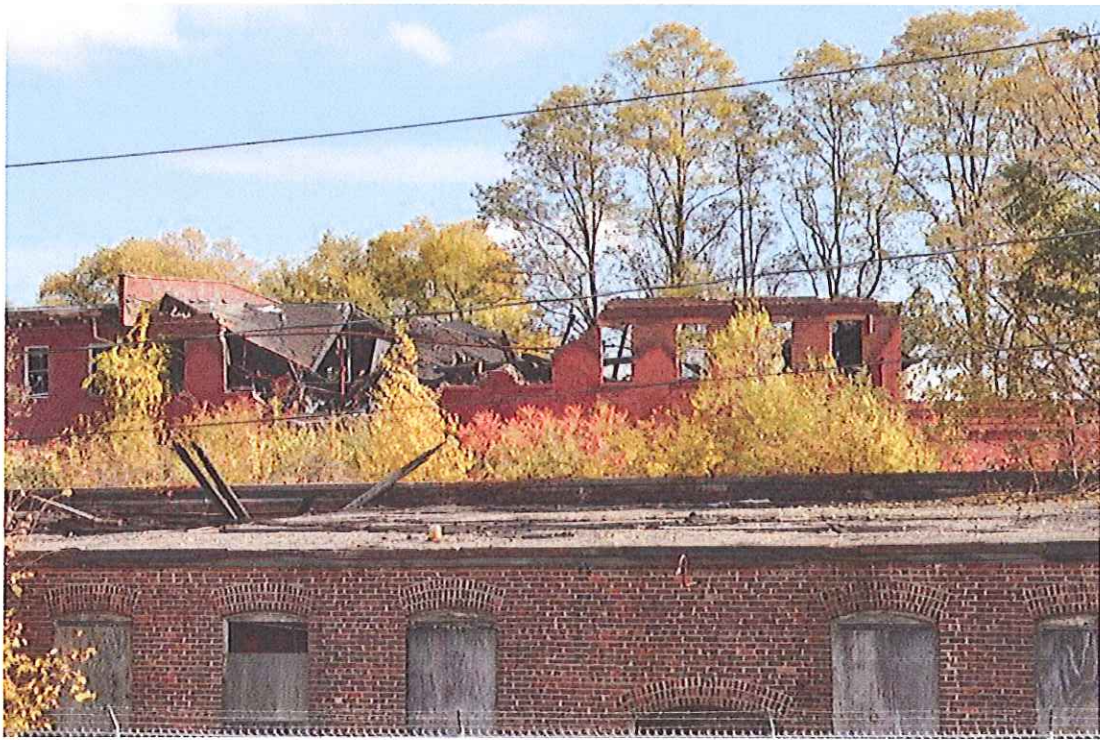
**Building #8** (Photograph #46, 47 and #48) is a 1-1/2 story brick building (originally the waste/picker house and No. 6 carding and storage building, estimated to date to c. 1900) with a rectangular plan and flat roof with parapet walls on the north and south ends. The building's east side is adjacent to a higher land elevation to the east, totally blocking access and visibility on this side.

Building #8 in the Facemate Complex was deemed not feasible for reuse due to its inability to realistically house possible functions studied in the April 2010 marketing study. It was not the subject of a structural evaluation, due to its severely deteriorated condition and market infeasibility. The building's small footprint, its poor and unattractive siting next to a hillside, and its physical condition are all factors in the determination that it is not cost-effective or feasible, in current market conditions, to reuse.

**46. Building #8, Facemate Complex, 5 West Main Street, Chicopee, MA. View of west elevation, Photographer facing SE, October 2010**

**47. Building #8 (with #12 in background) Facemate Complex, 5 West Main Street, Chicopee, MA. View of west and south elevation, Photographer facing E, October 2010**

**48. Building #8 (with #12 in rear), Facemate Complex, 5 West Main Street, Chicopee, MA. View of roof condition of both buildings, Photographer facing E, October 2010**
